# Manhole Inspection Summary

Manhole # S23EE1012MH

Insp Date: **3/15/07 2:10 PM**

**Location** Address: **1518 COX ST**

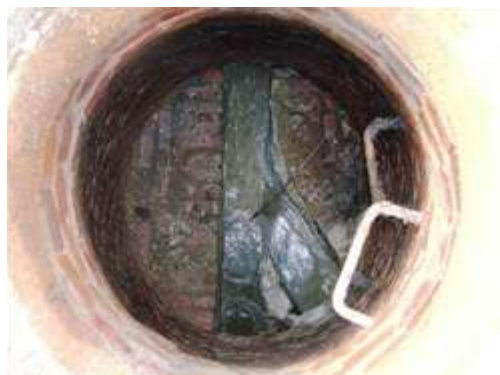
Top View

Evidence of surcharge - Bench debris.  
Corroded steps.

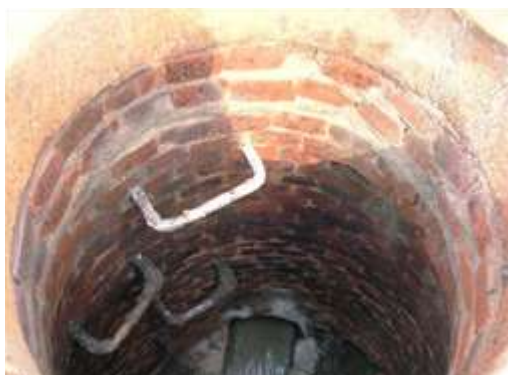
Defect

Adjustment deterioration and infiltration.  
Corbel and Barrel infiltration.

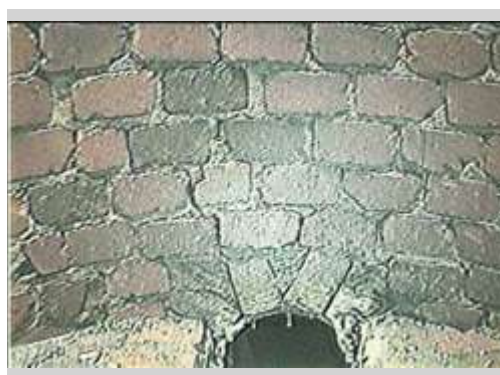
Defect

Barrel deterioration and infiltration.

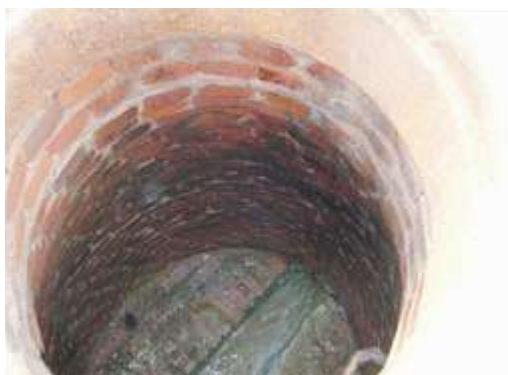
Defect

Adjustment, Corbel and Barrel infiltration -  
other side.

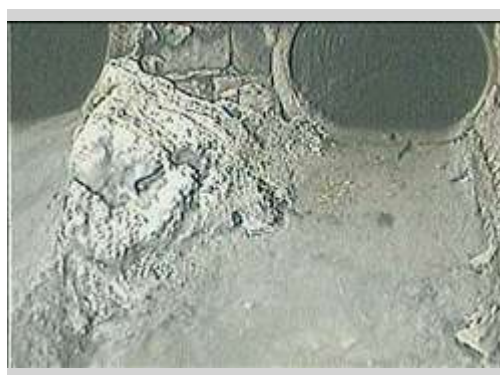
Defect

Bench deterioration.

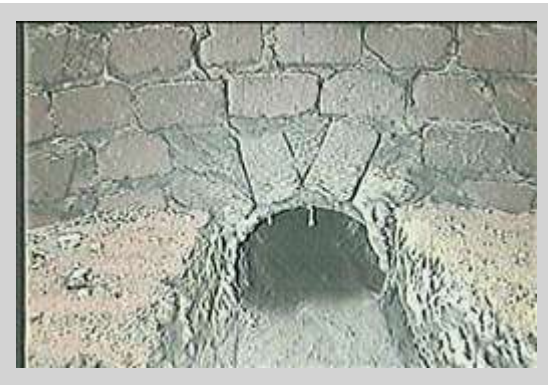
### 8 in. Circular Gravity Sewer Pipe Out @ 12 O'Clock

Barrel deterioration and infiltration. Channel deterioration.

Infiltration: **Evidence** Pipe Seal Cond: **Roots**

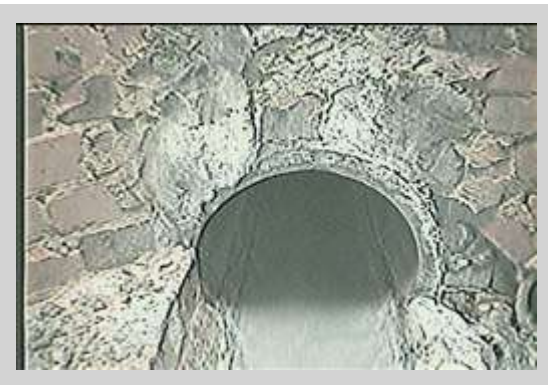
### 12 in. Circular Gravity Sewer Pipe In @ 5 O'Clock

Deposits: ☐ None ☐ Mud ☐ Sludge ☐ Debris ☒ Grease

Infiltration: **Evidence** Pipe Seal Cond: **Unknown**

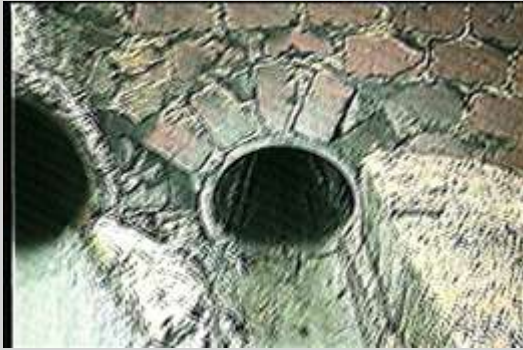
Pipe In @ 6 O'Clock

Barrel deterioration and infiltration. Channel deterioration.

Deposits: ☐ None ☐ Mud ☐ Sludge ☐ Debris ☒ **Grease**
